**TYPICAL DETAILS OF ATTENUATION TANK USING GEOCELLULAR MODULAR UNITS (SIDE VIEW)**  
NTS

**TYPICAL DETAILS OF ATTENUATION TANK USING GEOCELLULAR MODULAR UNITS (FRONT VIEW)**  
NTS

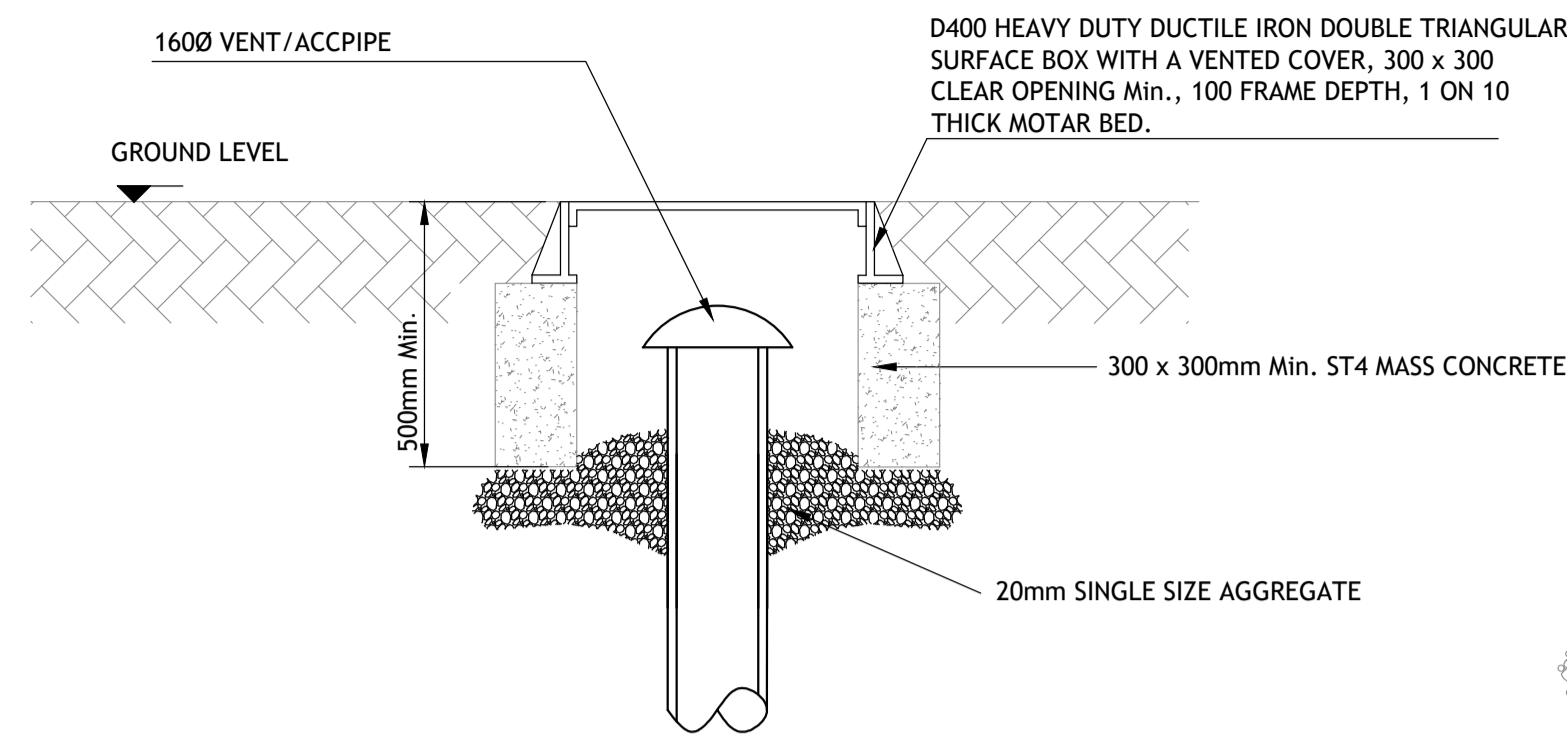
**VENTILATION BOX DETAIL**  
(NTS)
